Detection of incorrect manufacturer labelling of hip components

Abstract We describe the case of a 53-year-old man who underwent a left metal-on-metal hip resurfacing in 2015. Component size mismatch (CSM) was suspected because of the patient's immediate post-operative mechanical symptoms and high metal ion levels. Surgical notes indicated the appropriate combinations of implants were used. However, we detected a mismatch using computed tomography. Revision was performed and subsequent measurements of explanted components confirmed the mismatch. To our knowledge, this case is the first report of a CT method being used in a patient to pre-operatively identify CSM.

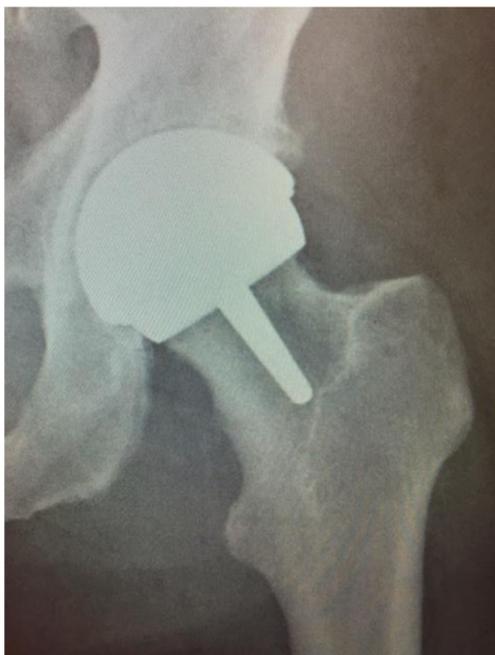
Fig. 1 Post-operative anterior–posterior plain film radiograph of the patient’s left hip. No cause of the patient’s mechanical symptoms was detected

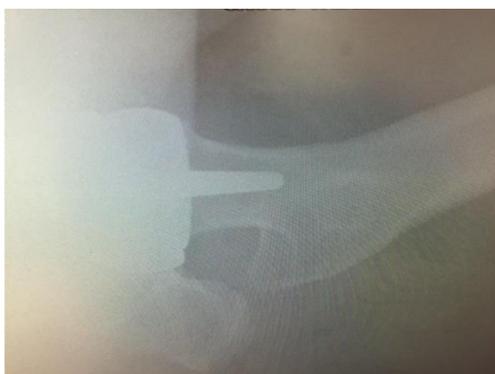
Fig. 2 Post-operative lateral plain film radiograph of the patient’s left hip. No cause of the patient’s mechanical symptoms was detected

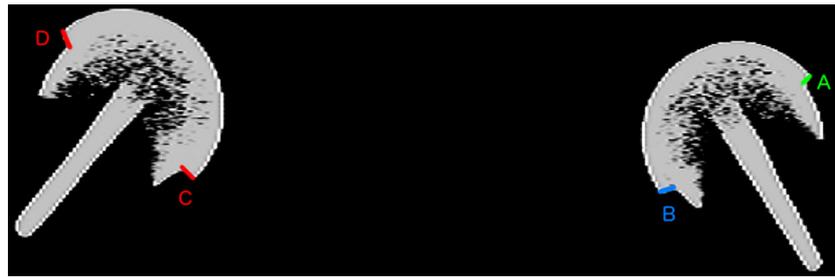
Fig. 3 A 2D CT coronal slice of the patient with the mismatched left hip resurfacing (*right*) and the patient's previous right hip resurfacing (*left*) in view. The femoral head of the mismatched component is not sitting

The same principle can be applied to 2D CT slices (Fig. 3), by comparing the distance between the outer surface of the acetabulum and the femoral head (AC–FH). Owing to metal artefact this was only possible at the edge of the acetabulum. For this reason, patients with mismatches due to oversized heads may go undetected because at the acetabular edge oversized femoral heads are centrally located and the AC–FH distance is equal (Fig. 7). We therefore recommend that 3D models are still generated to accurately visualise the difference between the femoral and acetabular centre of rotations in all planes.

The method was used to detect a mislabelled oversized cup, as the centre of rotation of the acetabular and femoral head components did not overlap, plus the femoral head did not sit

centrally in the acetabular component with *B* being 1.5 times greater than *A*. On the previous right hip resurfacing, with correctly paired components, the femoral head is centrally placed (*C* to *D*)

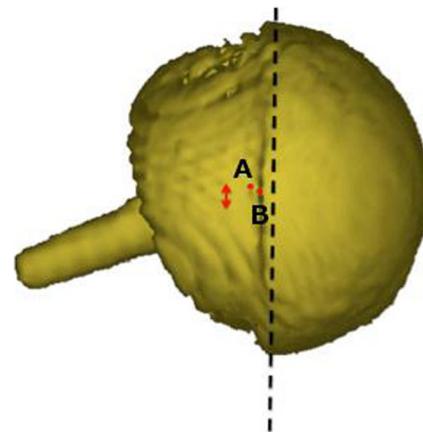
Three-dimensional analyses of the CT scan indicated a potential CSM (Figs. 4, 5). Results suggested that the acetabular-bearing diameter was 50 mm, highly suggestive of a 2-mm CSM, with the acetabular bearing surface 2 mm greater than the femoral head. Revision was recommended on this basis.

Fig. 4 Three-dimensional model of the patient's metal-on-metal (MoM) resurfacing. The acetabular (*A*) and femoral head (*B*) centres of rotation have been marked and the *red arrow* demonstrates that the two points are not overlapping, which indicated component size mismatch (CSM)

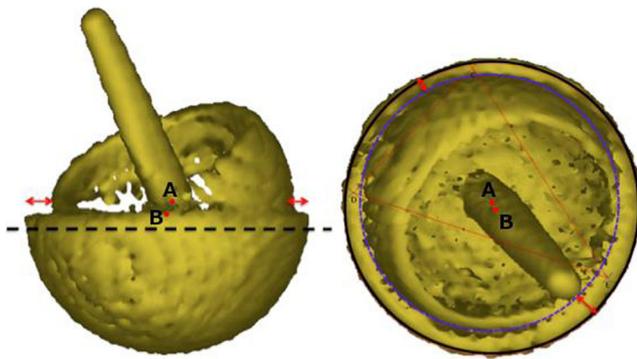
Fig. 5 Lateral (*left*) and true anterior–posterior of the acetabular cup (*right*) views of a three-dimensional model of the patient's MoM resurfacing. *A* is the acetabular centre of rotation and *B* is the femoral head centre of rotation. The *red arrows* indicate that the femoral head is not centred in the acetabulum, which suggests CSM

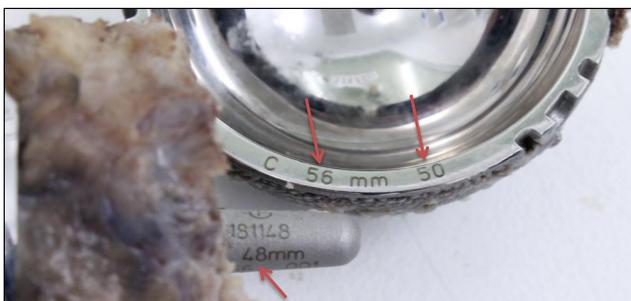
Currently, proper procedure dictates that only the labels on the boxes are checked and noted. This is because, while the engravings on the acetabulum (Fig. 6) can be seen at revision,

Fig. 6 Photo of the revised Adept hip resurfacing removed from the 53-year-old gentleman. Manufacturer labels in the surgical notes record the components as being a 56-mm cup designed for a 48-mm head and a 48-mm head. Engravings (*red arrows*) and coordinate measuring machine measurements confirm the CSM, as the cup is actually a 56-mm cup designed for a 50-mm head

To reduce the incidence of CSM, we recommend that component sizes are documented on the whiteboard in theatre (in the same way the swab count check is performed). In addition, this case highlights the importance of attempting to check the engravings on the acetabular component after insertion and not just relying on the boxes/stickers. However, this is not

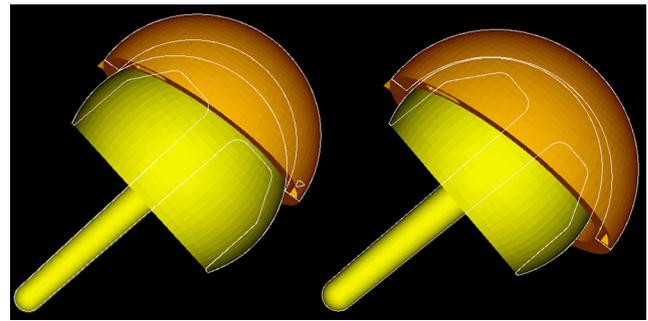
centrally in the acetabular component (Figs. 4, 5). If the femoral component was oversized, the centres of rotation of the acetabulum and femoral head components would not overlap, but the femoral head would remain centrally positioned in the acetabulum (Fig. 7).

Fig. 7 Two 3D models of potential CSMs: oversized femoral head (*left*); oversized acetabulum (*right*). The *white outline* reveals that the femoral head sits centrally in the acetabulum in cases where the femoral head is oversized. In CSM cases where the acetabulum is oversized (as presented) the femoral head does not sit centrally

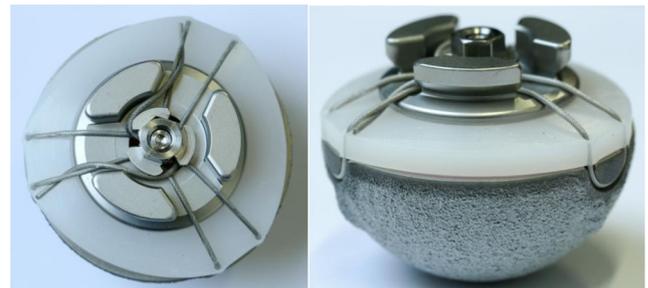
they are not visible before implantation as they are packaged with an impactor cap attached (Fig. 8).

Fig. 8 Photo of an acetabular component with the impactor cap still attached. The impactor cap covers the engravings and is removed only after insertion

Future work will incorporate the lessons learned from this case and retrieval data on mismatches to develop a modified WHO checklist with the aim of reducing the incidence of CSM. Within the modified WHO checklist it would be imperative for the engravings on the components to be directly visualised, either post-implantation or, if this proves too difficult to implement, pre-implantation, following a redesign of the impactor caps.
